| Equipment | Main Feed Cable |
| Location | 7' Crusher Room: Main Crusher Feed |

Date: 10/14/2005 Thermographer: J. Devi Thorp/Mark Whitledge

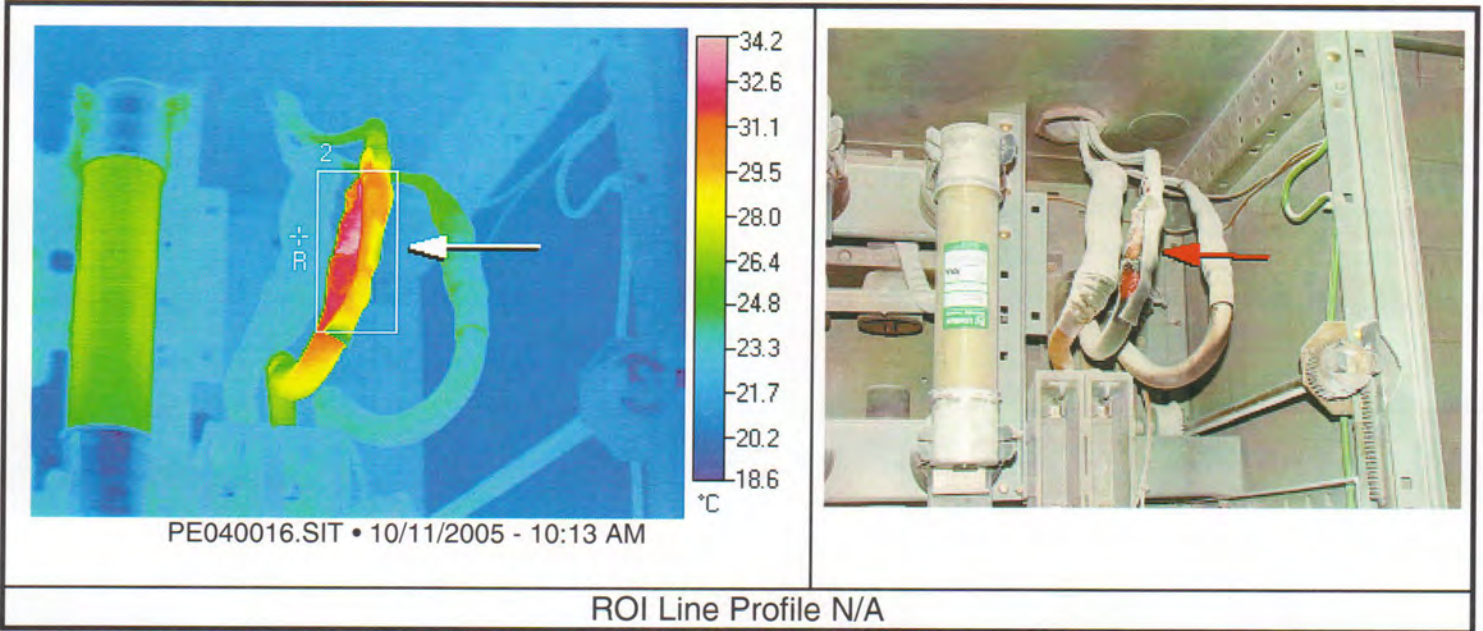
| Avg | | 26.6 °C |
| Min | | 20.8 °C |
| Max | 22.9 °C | 34.2 °C |
| Delta | | 11.3 °C |

| Condition | Overheating |
| Causes | Loose or improper splice |
| Temperature Rise | 11.3°C |
| Repair Priority Level | Level 4: Major discrepancy; repair immediately. |

| Action Suggested | Re-splice cable. Physical damage from heating is visible on outer insulation. |
