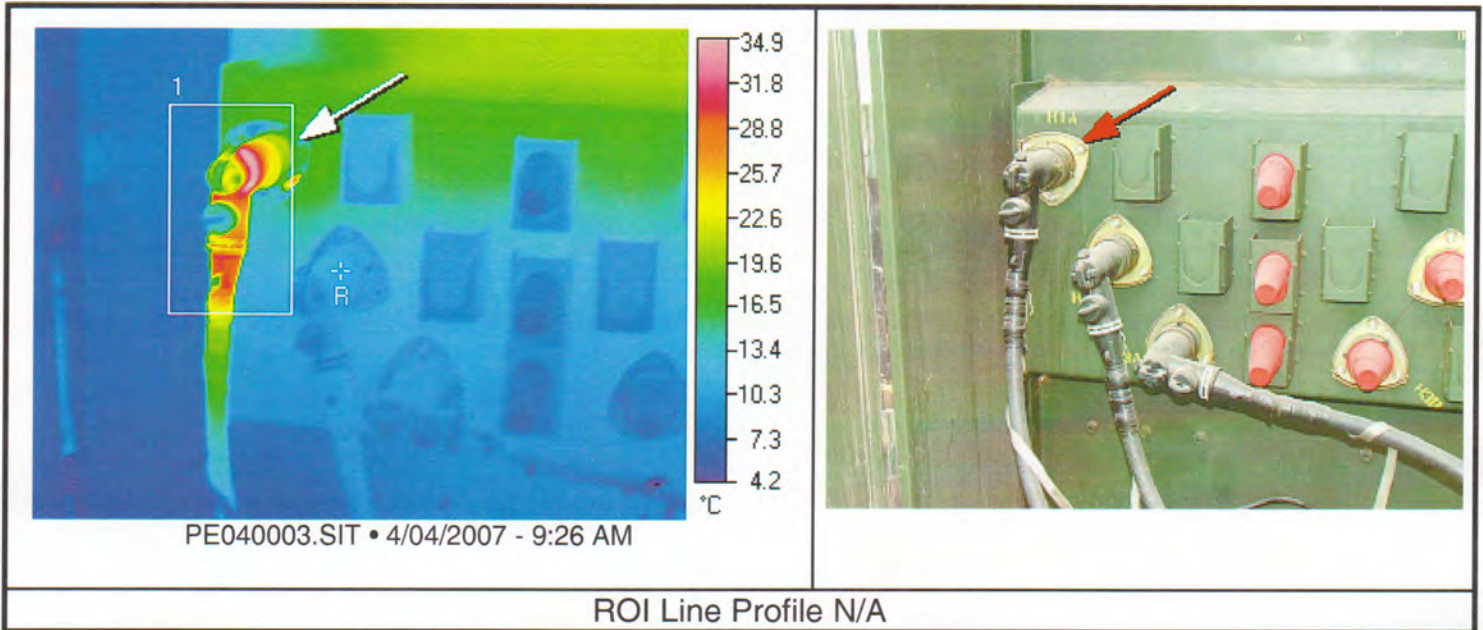
Rect1	Ref.
Emiss.	1.0	1.0
Avg	14.5 °C	
Min	6.7 °C	
Max	34.9 °C	11.5 °C
Delta	23.4 °C

Equipment	H1 bushing connection.
Location	North and South transformer
Condition	Overheating
Causes	Loose, dirty, or corroded connection.
Load	Unknown
Temperature Rise	23.4°C
Repair Priority Level	Level 4: Major discrepancy; repair immediately.
Action Suggested	Inspect, clean, and tighten connection.
Repairs Completed By:
